AIR CONDITIONER FROST BUILDUP

Form No. 3107322.004 10/96 ©1996 The Dometic Corp., LaGrange, IN 46761

DUO-THERM AIR CONDITIONER BULLETIN A20/6A AUGUST 1996

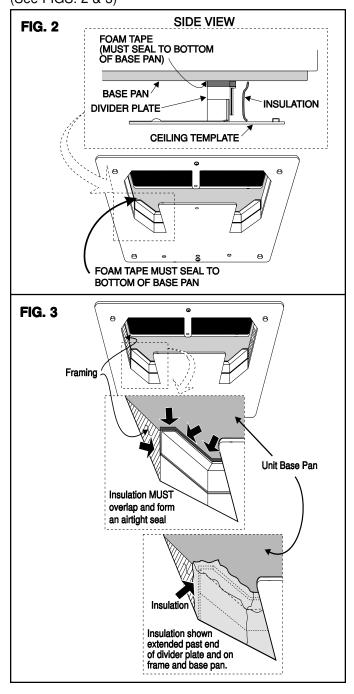
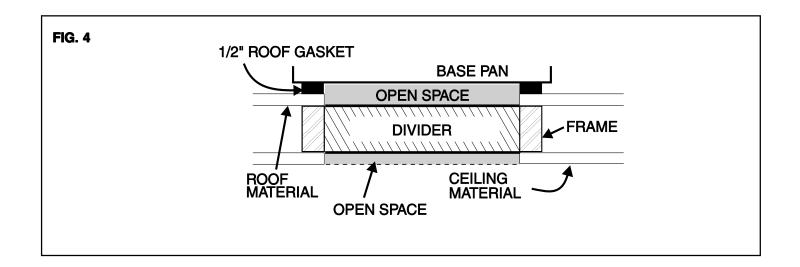
Duo-Therm's return air kits are designed to be installed tightly to the bottom of the base pan and ceiling template. Insulation supplied in the kit not only stops condensation from forming on the divider plate, but prohibits air leaking around it as well. The insulation is purposely oversized to be attached to the sides of the 14" x 14" opening and the base of the air conditioner and ceiling template. Make sure the data plate does not get covered with insulation. (See FIGS. 2 & 3)

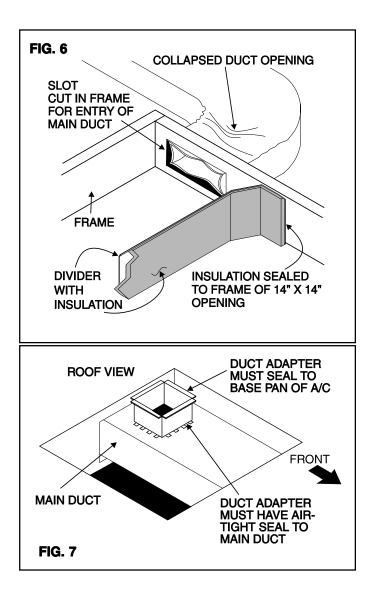
- D. Another method of connecting the discharge air to the coach's main duct uses Duo-Therm's return air kit. It uses half of the 14" x 14" opening as a discharge plenum. If the duct opening is not clean, restriction of air can cause the coil to freeze. The opening of the duct should be as large as possible to make the air distribution better in the coach and reduce freeze-up. (See FIG. 6).

- E. The final method of installation dumps the discharge air directly into the R.V.'s main duct. The duct is routed through the 14" x 14" opening. A duct adapter is used to connect the air conditioner to the main duct. If this connection is not made properly, cold air can migrate back into the return air path and make conditions right for freeze-up. Be sure the duct adapter is sealed to the main duct and air conditioner. (See FIG. 7).

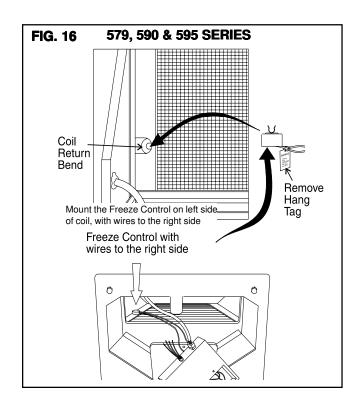
- a. Snap freeze control into place on return bend located at left side of evaporator coil as follows:
 - Locate "D" shaped notch in flange of evaporator coil.
 - 2) Place the horseshoe end of freeze control through this notch and snap onto coil return bend. When positioned correctly, control wires will be 90° to direction of coil fin surface. (Refer to FIG. 16)

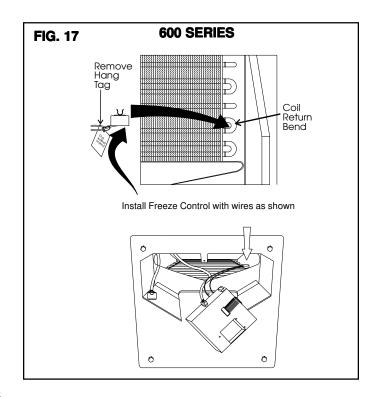
- a. Snap the freeze control into place on return bend located at right side of evaporator coil as follows:
 - 1) Locate vertical return bend at lower right of evaporator coil.
 - 2) Place the horseshoe end of freeze control onto this coil return bend and snap into place. When positioned correctly, control wires will be 90° to direction of coil fin surface. (Refer to FIG. 17).
