This program will address the most common system problems associated with the A&E Patio Awnings supplied by The Dometic Corporation. Our intent is to provide you with a guideline of checks to make, should you encounter one of the following symptoms.

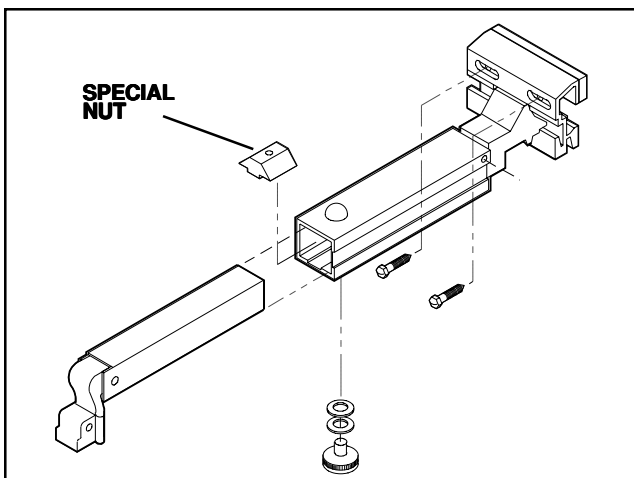
On some arm assemblies the nutsert has been replaced with a **SPECIAL NUT**. If the knob will not tighten, first separate the rafter assembly. Turn the knob to determine if the special nut is stripped. If so, replace the special nut. If you cannot turn the knob, it will be necessary to replace both the special nut and the back adjustment knob.

**NOTE:** The special nut could be a large hex nut as well as the one shown.

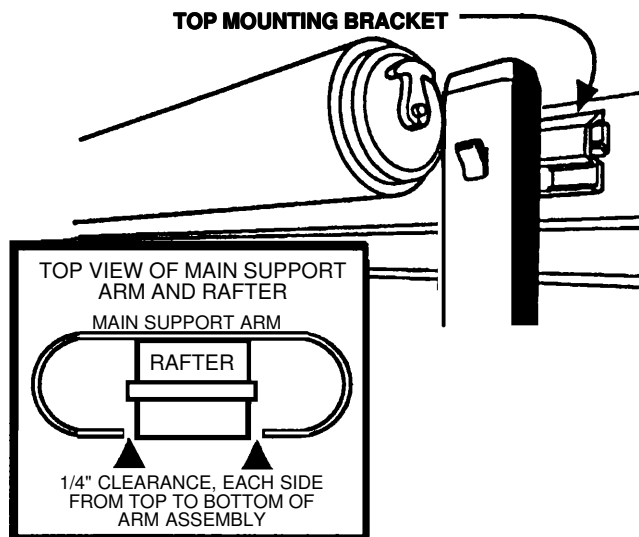
### 1.5 TOP MOUNTING BRACKETS

The top mounting bracket supports the main rafter assembly to hold the awning in the open extended position, and allows the rafter to pivot into the "C" channel of the main support arm. Each top mounting bracket should be mounted directly over the awning rail so the screws go through the "C" portion of the rail.

On the Series 9000 awning the top mounting bracket can be mounted lower when possible. If the top mounting bracket is mounted above center of the awning rail, the aluminum guard may not cover the fabric completely in the closed position. If this is the case, relocate the top mounting bracket accordingly.

The top mounting brackets have slotted holes for the mounting screws, allowing them to be adjusted side to side. To adjust the brackets, close the awning and sight down the main support arm and the main rafter. The clearance on each side of the rafter should be approximately 1/4 inch. If clearance is not appropriate, adjust the top mounting bracket(s) as necessary.
