This program will address the most common system problems associated with the A&E Patio Awnings supplied by The Dometic Corporation. Our intent is to provide you with a guideline of checks to make, should you encounter one of the following symptoms.

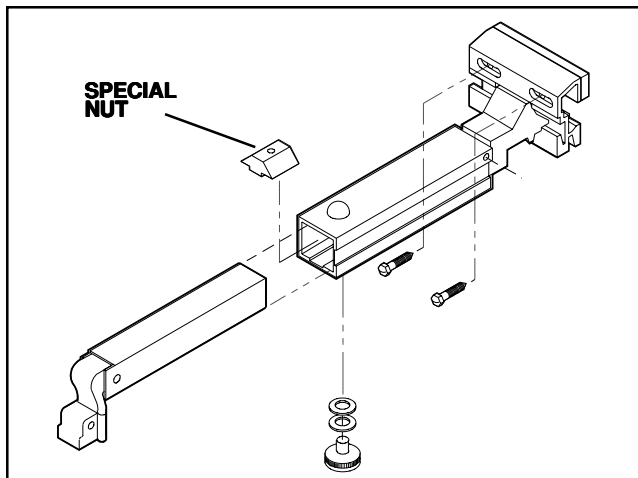
On some arm assemblies the nutsert has been replaced with a **SPECIAL NUT**. If the knob will not tighten, first separate the rafter assembly. Turn the knob to determine if the special nut is stripped. If so, replace the special nut. If you cannot turn the knob, it will be necessary to replace both the special nut and the back adjustment knob.

**NOTE:** The special nut could be a large hex nut as well as the one shown.

The **nutsert** is simply a threaded fastening device used to tighten down the black adjustment knob. If the knob will not tighten, first remove the secondary rafter assembly from the hardware. Turn the knob to determine if the nutsert is stripped or spinning. If so, replace the nutsert. If you cannot turn the knob it will be necessary to replace both the nutsert and the black adjustment knob.

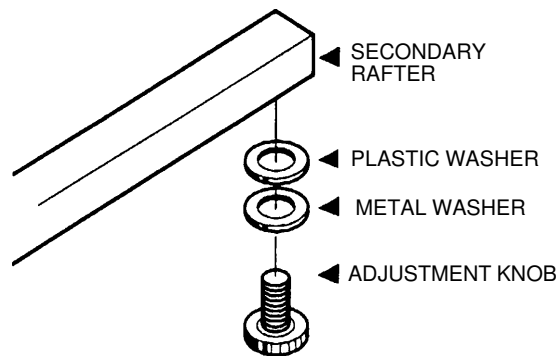
### 1.2 WASHER STACK-UP

Washer stack-up merely means the proper positioning of the washers on the stud of the black adjustment knob. Remove the knob and check for proper washer position. The plastic washer should be against the main rafter, and backed by the metal washer for stiffness. If the stack-up is not proper it should be corrected.

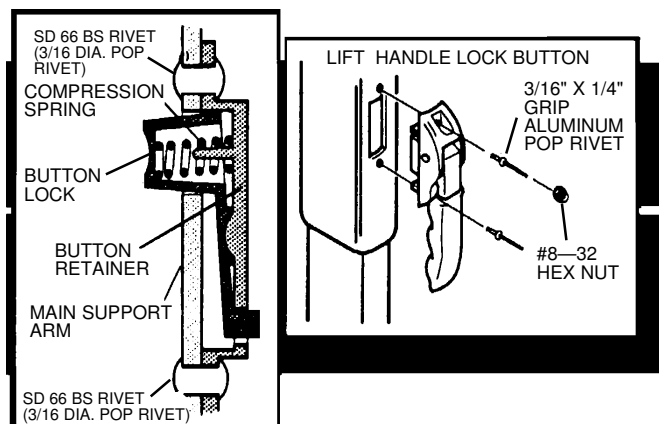
### 1.3 PUSH BUTTON ASSEMBLY

The push button assembly locks the main support arm to the adjustable arm assembly and controls the height of the awning in the open position. To check it, open the awning to full extension. Look inside the main support arm, and activate the push button to see if the locking pin is moving in and out of the hole in the adjustable arm assembly. If the locking pin does not move, or has been

broken off, the push button assembly must be replaced. At times the lock pin of the push button assembly can break off and jam between the push button housing and the adjustable arm assembly, making it difficult to extend the main support arm.

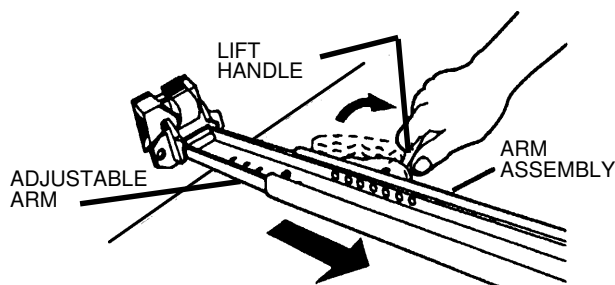
### 1.4 ADJUSTABLE ARM ASSEMBLY

The adjustable arm assembly allows for telescoping height adjustment of the main support arm, and it connects to the bottom mounting bracket to support the weight of the awning. If the main support arm cannot be extended freely, the adjustable arm assembly should be checked. Remove the adjustable arm assembly and check for nicks, burrs, bends or twists. If any deflection is noted, the adjustable arm assembly must be replaced. For ease of operation apply GO-EASY, a special lubricant.

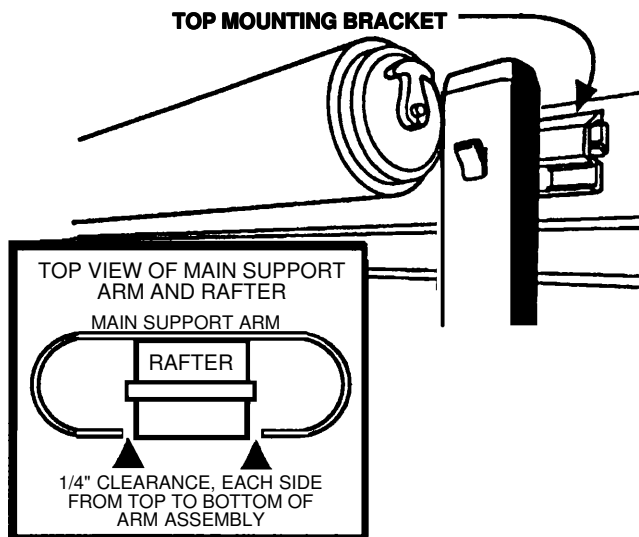
### 1.5 TOP MOUNTING BRACKETS

The top mounting bracket supports the main rafter assembly to hold the awning in the open extended position, and allows the rafter to pivot into the "C" channel of the main support arm. Each top mounting bracket should be mounted directly over the awning rail so the screws go through the "C" portion of the rail.

On the Series 9000 awning the top mounting bracket can be mounted lower when possible. If the top mounting bracket is mounted above center of the awning rail, the aluminum guard may not cover the fabric completely in the closed position. If this is the case, relocate the top mounting bracket accordingly.

The top mounting brackets have slotted holes for the mounting screws, allowing them to be adjusted side to side. To adjust the brackets, close the awning and sight down the main support arm and the main rafter. The clearance on each side of the rafter should be approximately 1/4 inch. If clearance is not appropriate, adjust the top mounting bracket(s) as necessary.

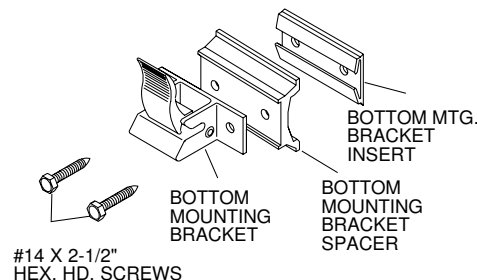
### 1.6 BOTTOM MOUNTING BRACKETS

The bottom mounting brackets are screwed to the floor line of the unit, and they support the weight of the awning. They also provide a quick release to set up the awning in the patio

position. If a bottom mounting bracket settles, sags, or becomes loose it can reduce the clearance between the top casting of the torsion and the extension of the top mounting bracket, making operation difficult.

Check the bottom mounting bracket for looseness or settling, and tighten or reposition it accordingly for proper operation.

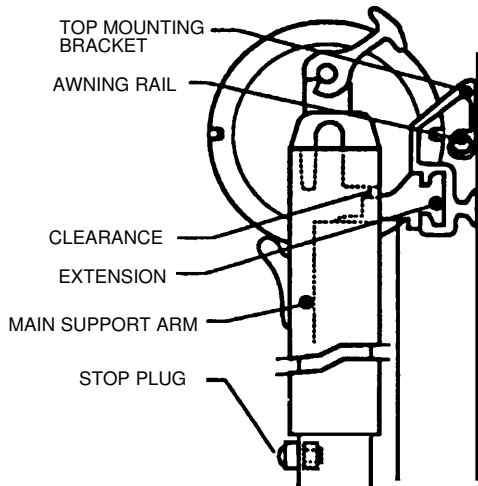
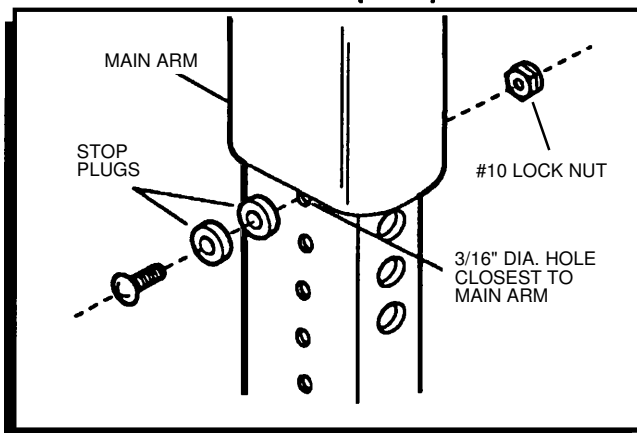
### 1.7 STOP PLUG

The stop plug is a mechanical stop that supports the main arm when opening and closing the awning. It controls the clearance between the top casting of the torsion to the extension of the top mounting bracket. This clearance should be 1/4 inch to 1 inch. To adjust the clearance, raise or lower the stop plug as needed. On the 9000 and 9500 Series awning the clearance should be kept to a minimum for best operation.

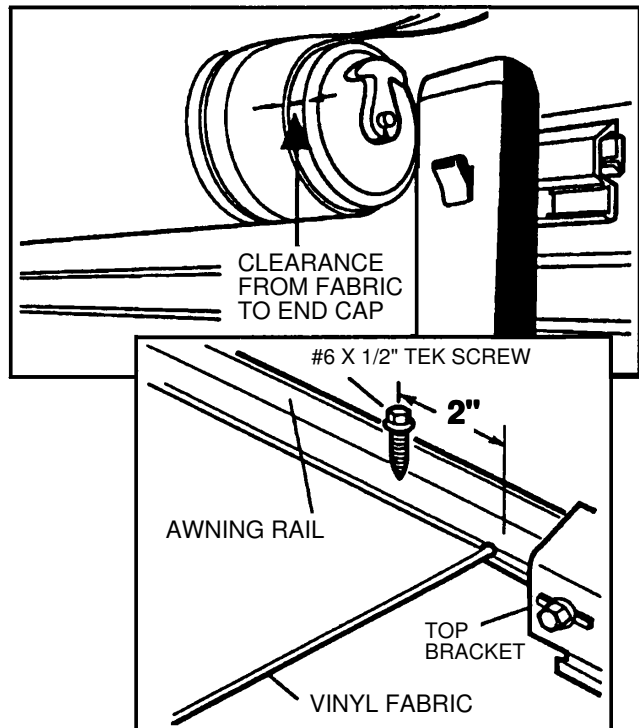
**2.1 POSITION**

For the awning to operate properly the fabric must be positioned properly in the awning rail and on the roller tube. Open the awning and check the position of the fabric between the top mounting brackets. If the fabric is not centered, remove the tek screws, center it, and replace the screws.

When the fabric is properly positioned, next check the position of the fabric on the roller tube. The clearance from the end cap of the torsion assembly to the edge of the fabric must be the same on each end. If it is not, adjust the fabric on the tube as necessary. On the Elite 9000 and 9500 awning the fabric is held in place to the weatherguard with 1/8" pop rivets. Check the position of the fabric at each end of the weatherguard. If the fabric has shifted, remove the pop rivets, center the fabric and re-rivet.

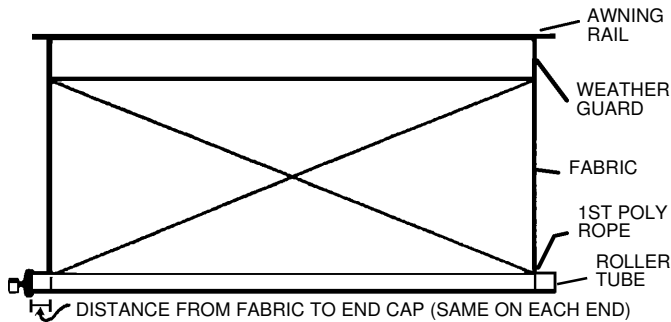
**2.2 SQUARE**

To check fabric for square, measure from the top right hand corner of the fabric (not the weatherguard) to the bottom left hand corner at the poly rope. Now measure from the top left hand corner to the bottom right hand corner as shown below.

In this check, the difference of the two dimensions should be no more than one inch. If it is more, the fabric is out of square, and replacement would be necessary.

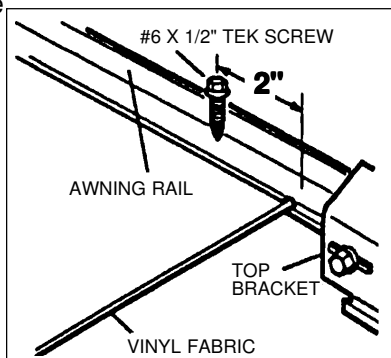
### 2.3 WEATHERGUARD

The weatherguard is the last 15 inches of the awning that encloses the fabric in the rolled up position. It protects the striped fabric from the environment and elements. The weatherguard is a heavy 17 oz. vinyl fabric.

When the vinyl weatherguard or fabric has excessive wrinkles, it will be necessary to stretch the weatherguard or fabric. Open the awning and allow the fabric to warm up. Remove one Tek screw, grasp the weatherguard, stretch it, and resecure the screw. Repeat this procedure for the other end, making sure to stretch each side an equal distance, keeping the fabric centered between the top mounting brackets. Close and reopen the awning three times. If wrinkles are still present, repeat the above stretching procedure. This may have to be done 4 or 5 times before all wrinkles disappear.

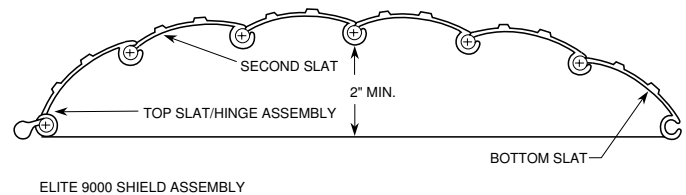
When the awning is fully extended, the aluminum guard should have an arch of at least 2 inches. The arch helps water to run off rather than between the sections of the guard.

To check the aluminum guard for proper arch, open the awning to full extension, making sure the fabric is taut. Hold a flat edge to the bottom of the guard and measure from the flat edge to the inside of the arch at its highest point. If the measurement is less than 2 inches, the guard should be replaced.

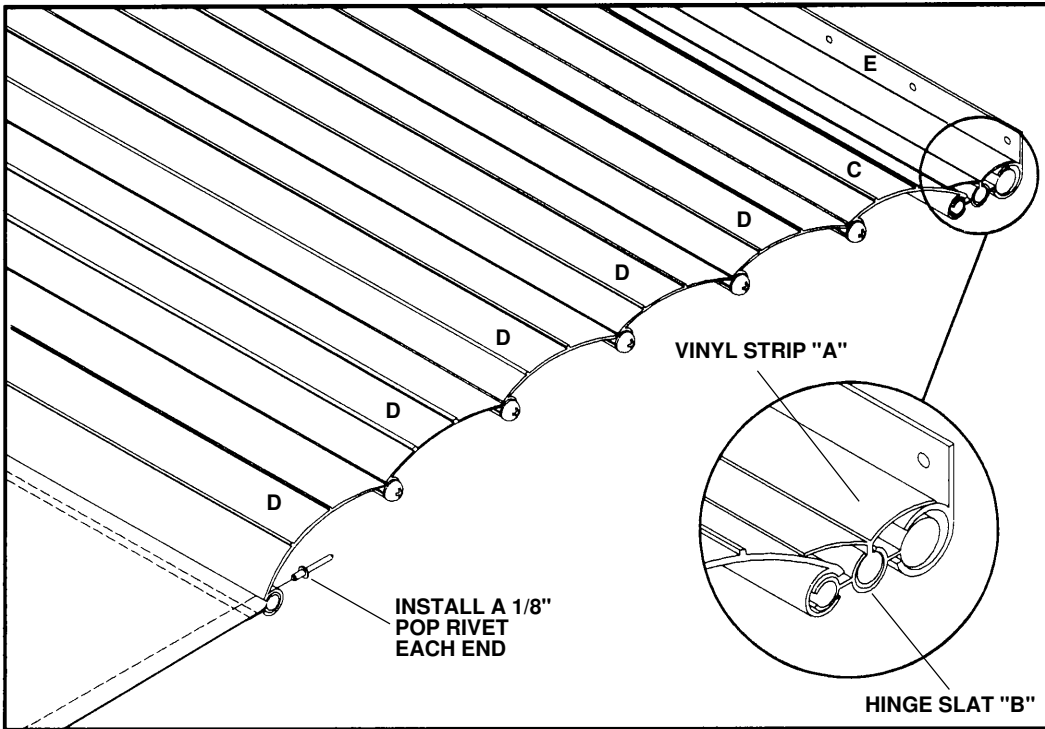
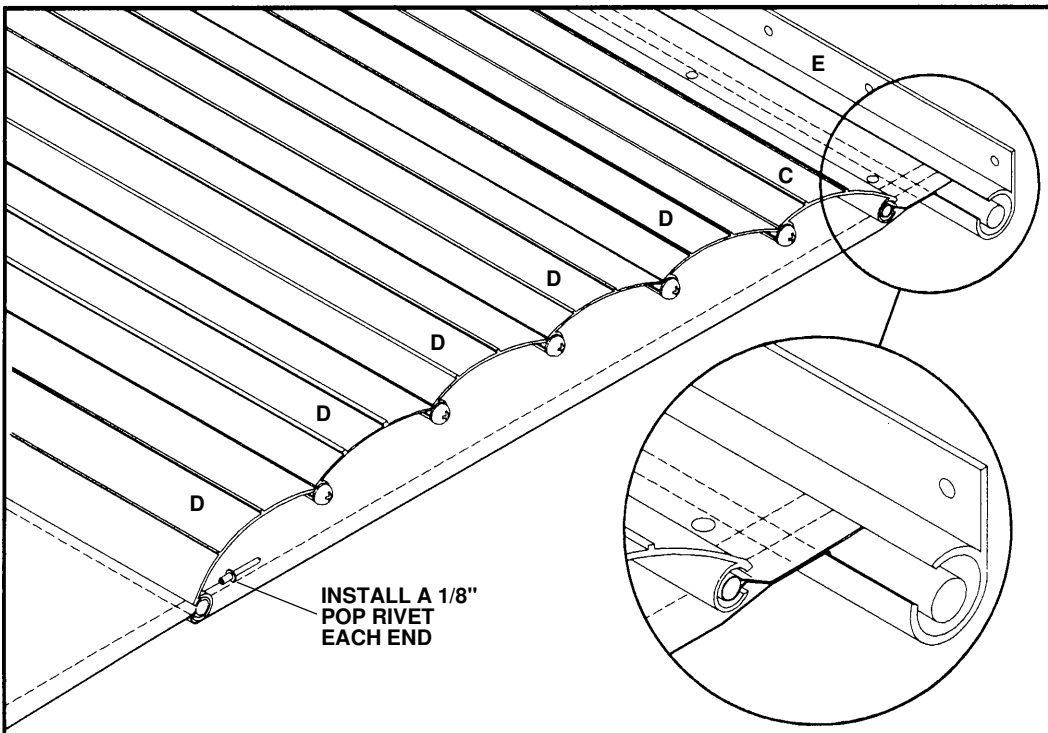
**9000 WITH HINGE SLAT**

- A - VINYL STRIP**
- B - HINGE SLAT**
- C - TOP SLAT**
- D - MAIN SLAT**
- E - AWNING RAIL**

**TOP SLAT "C"**  
VIEW RH END

**MAIN SLAT "D"**  
VIEW RH END

**HINGE SLAT "B"**

**VINYL STRIP "A"**

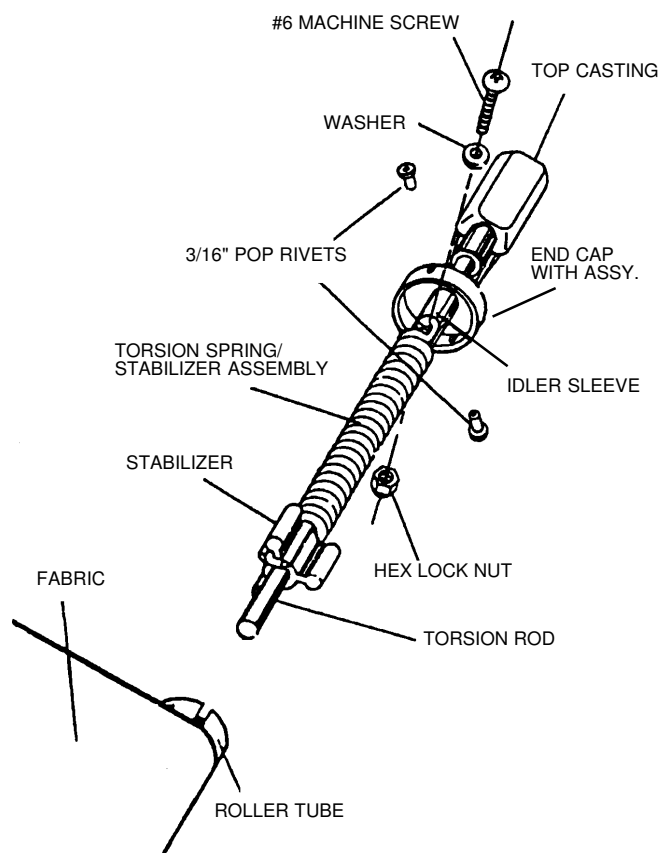
When difficulties are experienced in rolling the awning up, the tension on the torsion should be checked. In

most cases adding a few turns of torque to each end will correct the problem. If all tension has been lost, refer to the following chart and apply the specified number of turns as indicated. This must be done with the awning extended two feet away from the coach.

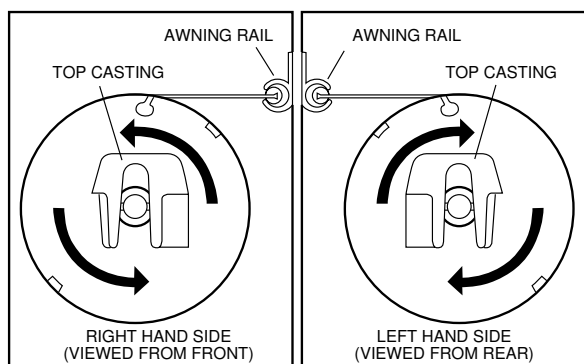
See Spring Identification Chart for No. of Turns

When winding the torsion, be sure to wind in the proper direction.

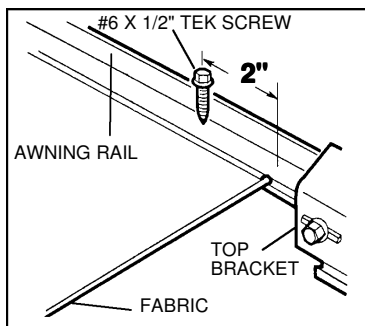
**2.12 TEK SCREWS**

The Tek screws are the two screws installed through the awning rail of the coach. They keep the aluminum guard from shifting in the awning rail. On vinyl and some acrylic awnings (see Sec. 2.5) they keep the fabric from shrinking with age. If one Tek screw is missing, the fabric will pull toward the remaining Tek screw causing the fabric to wrinkle.

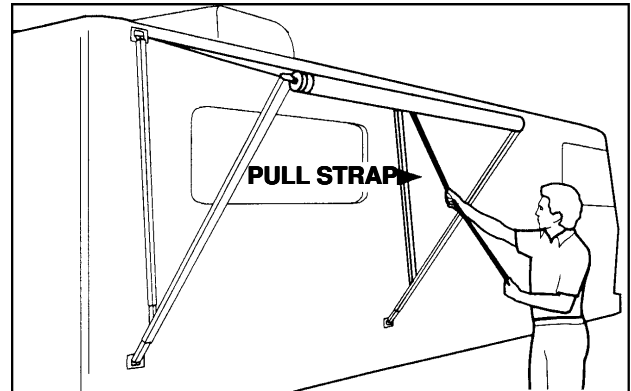
**3.2 CLOSING**

On the 9000 and 9500 Series, when rolling up the awning, the roller tube assembly should not be slowed down before reaching the aluminum guard. This could cause the roller tube to stall at the guard.
